**ESTIMATED SEDIMENT YIELD FROM COASTAL LANDSLIDES AND
ACTIVE SLOPE DISTRIBUTION ALONG THE BIG SUR COAST**

Addendum: Coastal Cliff Erosion Rates, Big Sur, CA

**A Report of Findings for the
COASTAL HIGHWAY MANAGEMENT PLAN
CALIFORNIA DEPARTMENT OF TRANSPORTATION, DISTRICT 5**

**Prepared by
C. Hapke^{1,2}
K. Dallas²
K. Green²**

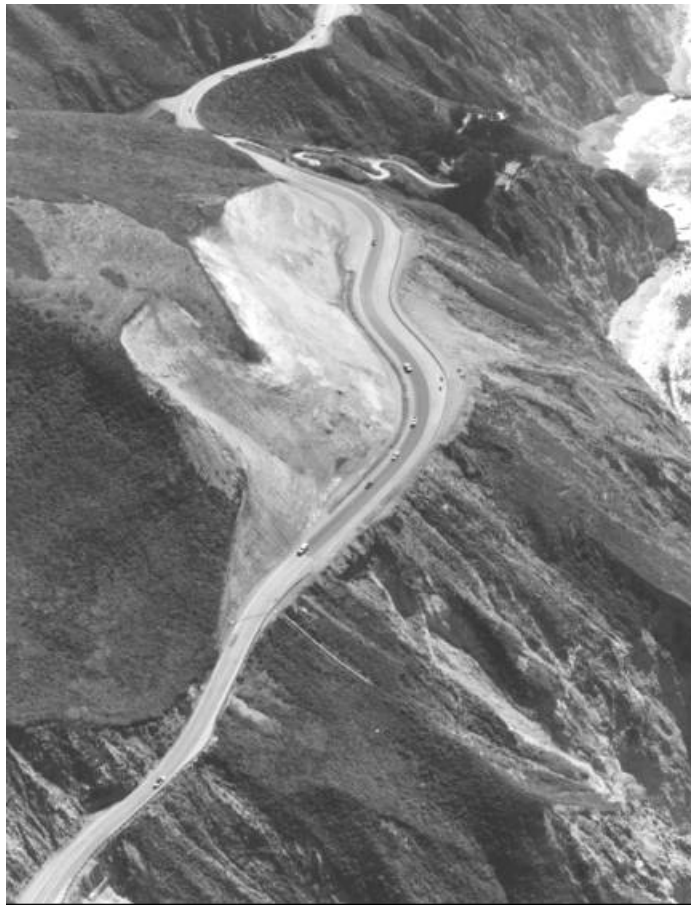
Figure 1: Large-scale landslides are common along the Big Sur coast and road closures from slides are common. This photo shows a section of Highway 1 after the repair of the Hurricane Point landslide (PM 58.0). Photo courtesy of Caltrans.

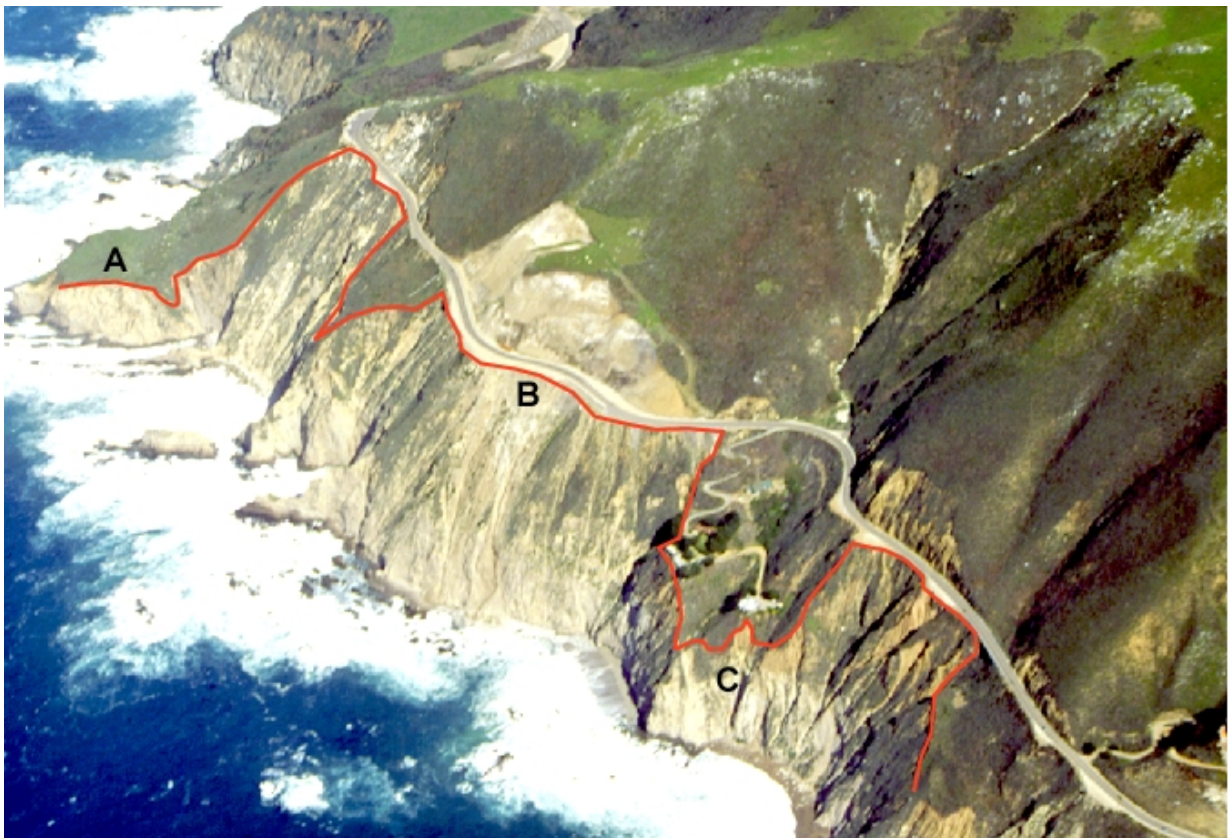
Figure 2: Oblique photo of the Big Sur coast near Hurricane Point. The red line shows the feature digitized as the cliff edge. The letters A, B, and C represent different morphologies of the cliff edge.

The erosion reference feature is well defined in some areas as a very sharp cliff edge (Fig. 2, location A), such as where marine terraces are present. In other parts of the coastline, the cliff edge is very poorly defined. In these areas the erosion reference feature is actually the edge of the man-made road grade in those areas where the basal portion of the slope is visibly active from the slope base to the road grade (Fig. 2, location B). In other areas the erosion reference feature is the active lower portion of the slope where the slope is not visibly active to the road grade (Fig. 2, location C). To avoid confusion in terminology, “cliff retreat rate” will be used to refer to the landward retreat of all of these features.
